*DoD Corrosion Prevention and Control Program*

## **Implementation of Remote Corrosion- Monitoring Sensor for Mission-Essential Structures at Okinawa**

Final Report on Project FAR-04 for FY06

August 2009

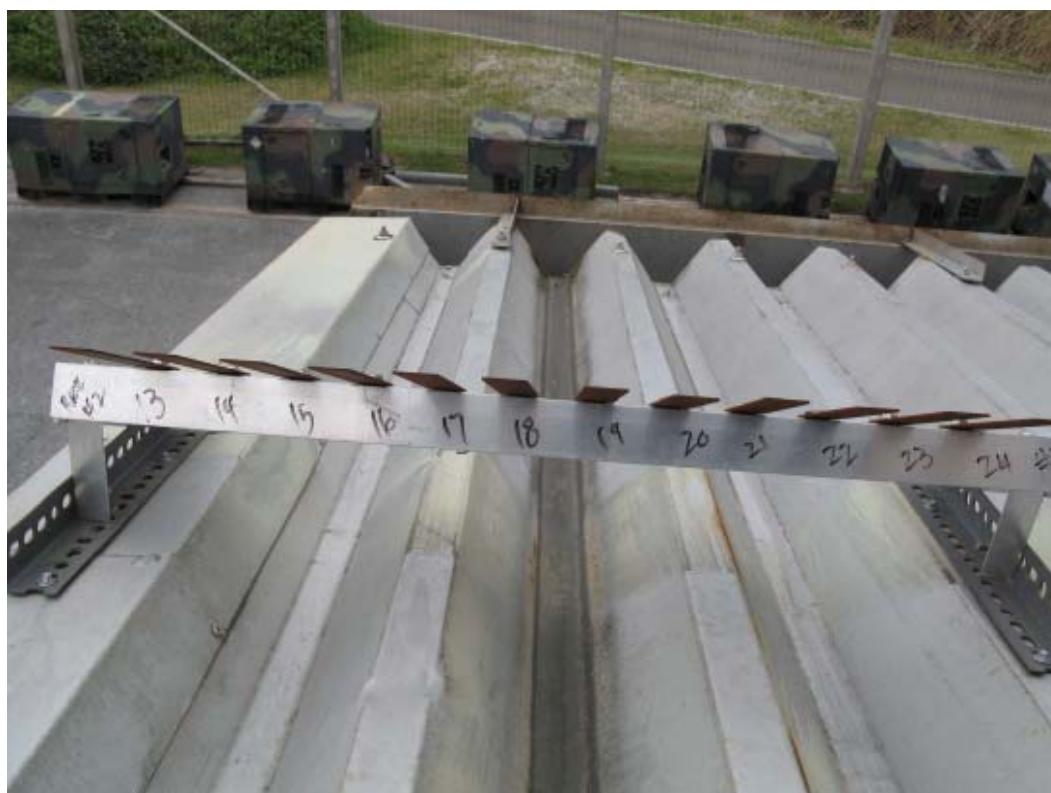
Figure 1. Coupons on rack mounted on roof of Bldg. 125.

The coupons and ER probes were installed on building number 125. The coupons were mounted to an aluminum frame using stainless steel bolts and nylon spacer washers. Stainless steel bolts were used in place of nylon bolts to withstand high wind loads. The coupons were electrically isolated. The resistance probe cables were secured to the roof and run down the outside wall in conduit. The ends of the probe cables were gathered in a NEMA 4X test box. Pictures of the coupons mounted on the roof and the

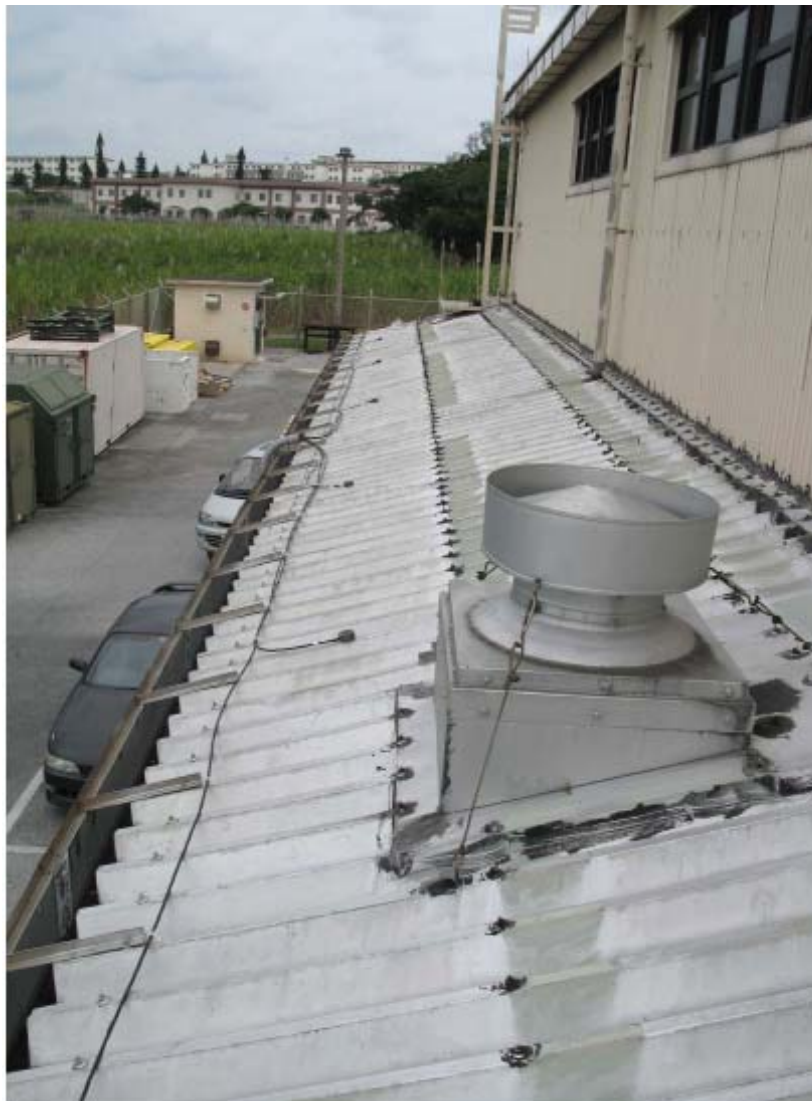
Figure 2. ER probes mounted on roof of Bldg. 125.

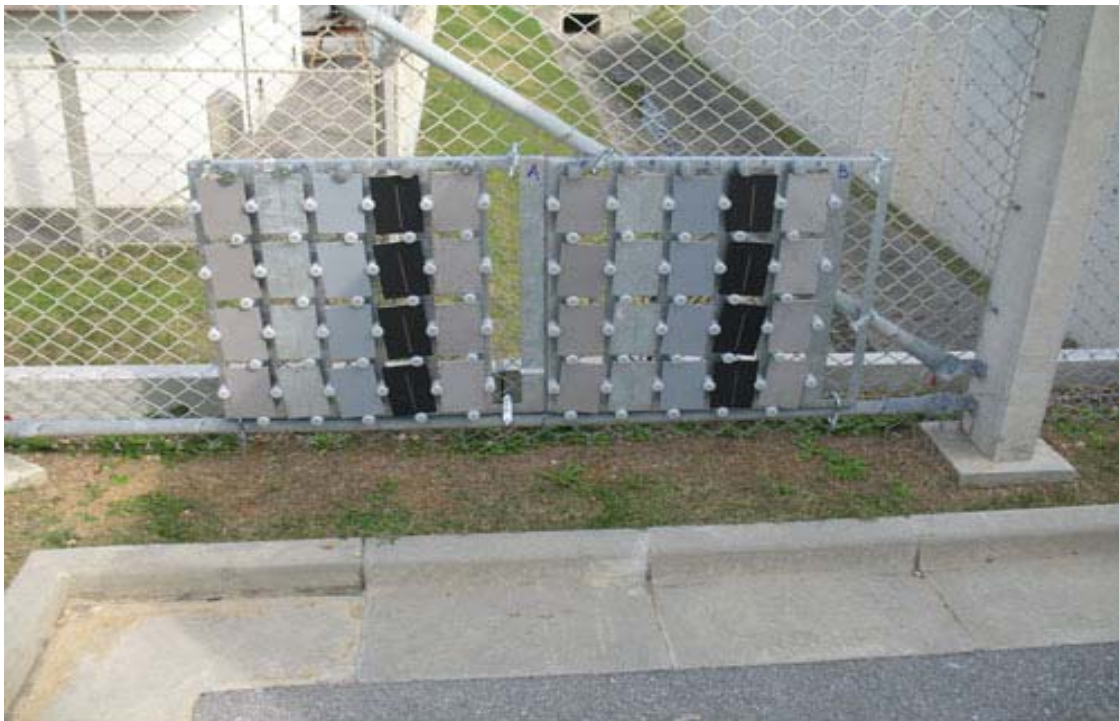
Figure 3. View of one of racks exposed at 500 ft location.

Hot-dip galvanized steel test racks for mounting the panels, porcelain insulators, and associated fasteners were used. The test racks and test panels were shipped to Torii Station, Okinawa in December 2006. The test panels were mounted on the racks during the same month. The test racks are shown in Figures 3 and 4. More details are provided in Appendix F.

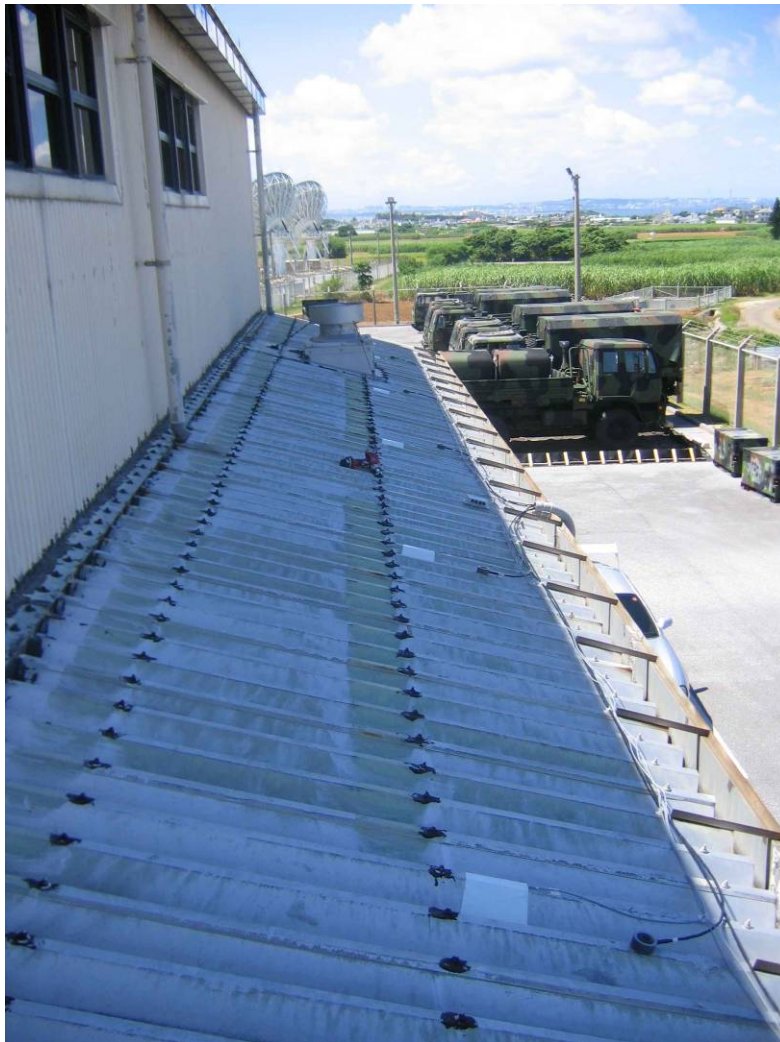
Figure 5. Installation of LPR corrosion sensors under primer and paint coating.

A more detailed description of the components of the system and how the sensors were installed is in Appendix G. Figures 5 and 6 show the sensors and interface box as installed.

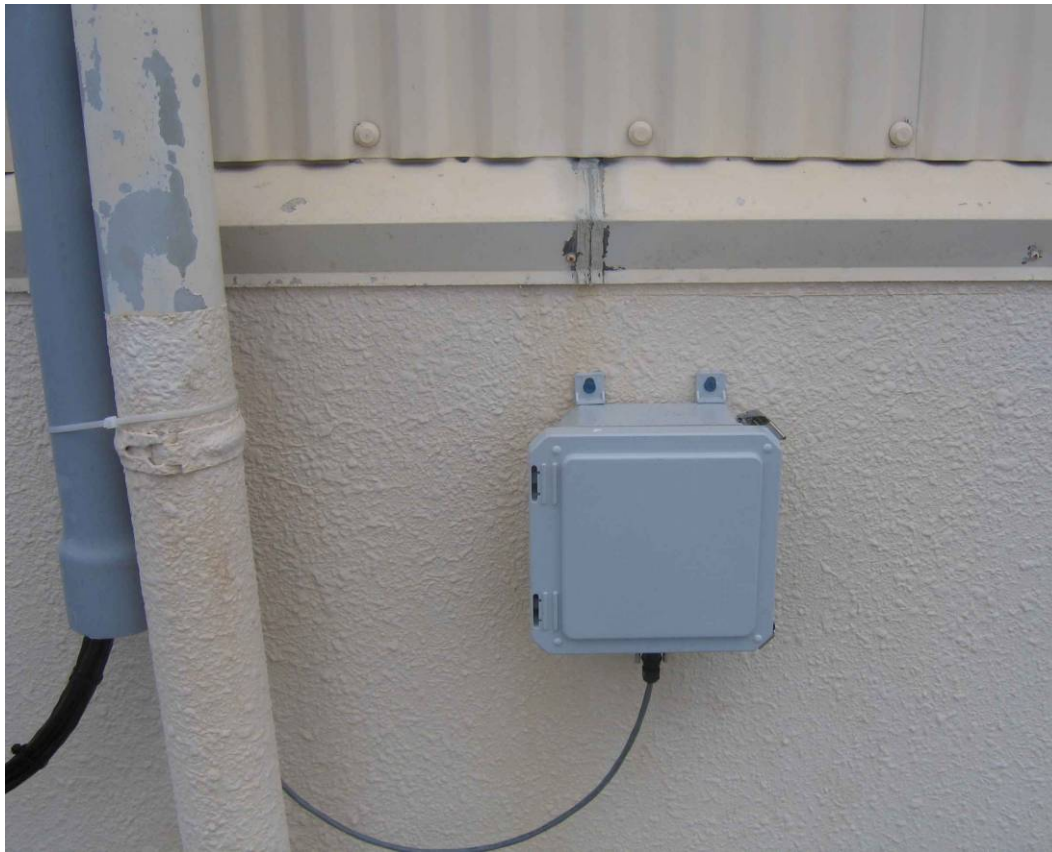
Figure 6. LPR corrosion sensor system serial interface box.

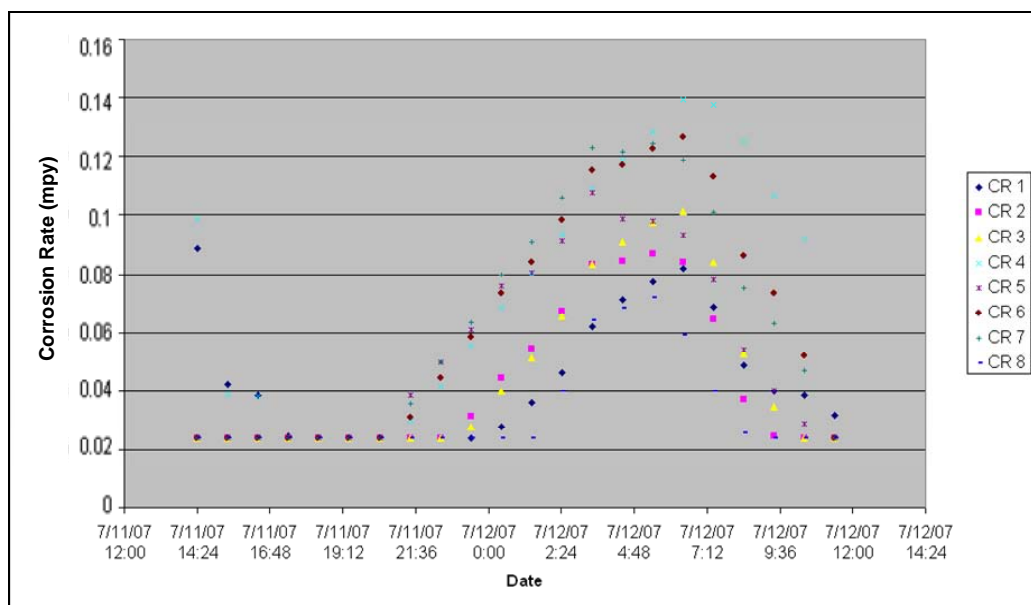
The 24 hours worth of data collected from the LPR sensors before the typhoon hit is represented in Figure 7. The data tracks with the increase of moisture during night hours and dissipation of moisture during day hours.

Figure 7. Data collected over 24-hour period.

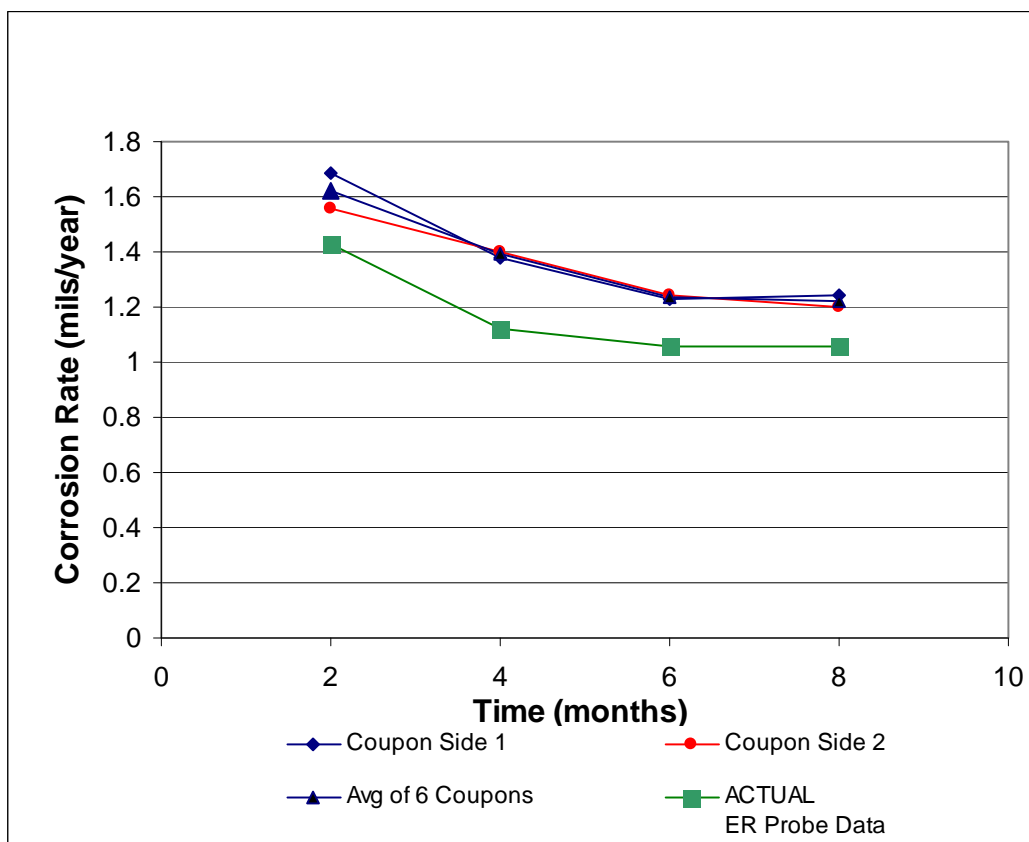
Month collected	Coupon side 1 (3 coupon average)	Coupon side 2 (3 coupon average)	Average of the six coupons	Electrical Resistance Probe (average of six)
2	1.683	1.554	1.619	1.43
4	1.379	1.401	1.390	1.12
6	1.230	1.246	1.238	1.06
8	1.240	1.200	1.220	1.06

Figure 8. Graph representing roof coupon and ER probe corrosion rates (mils per year vs 2 month interval points).

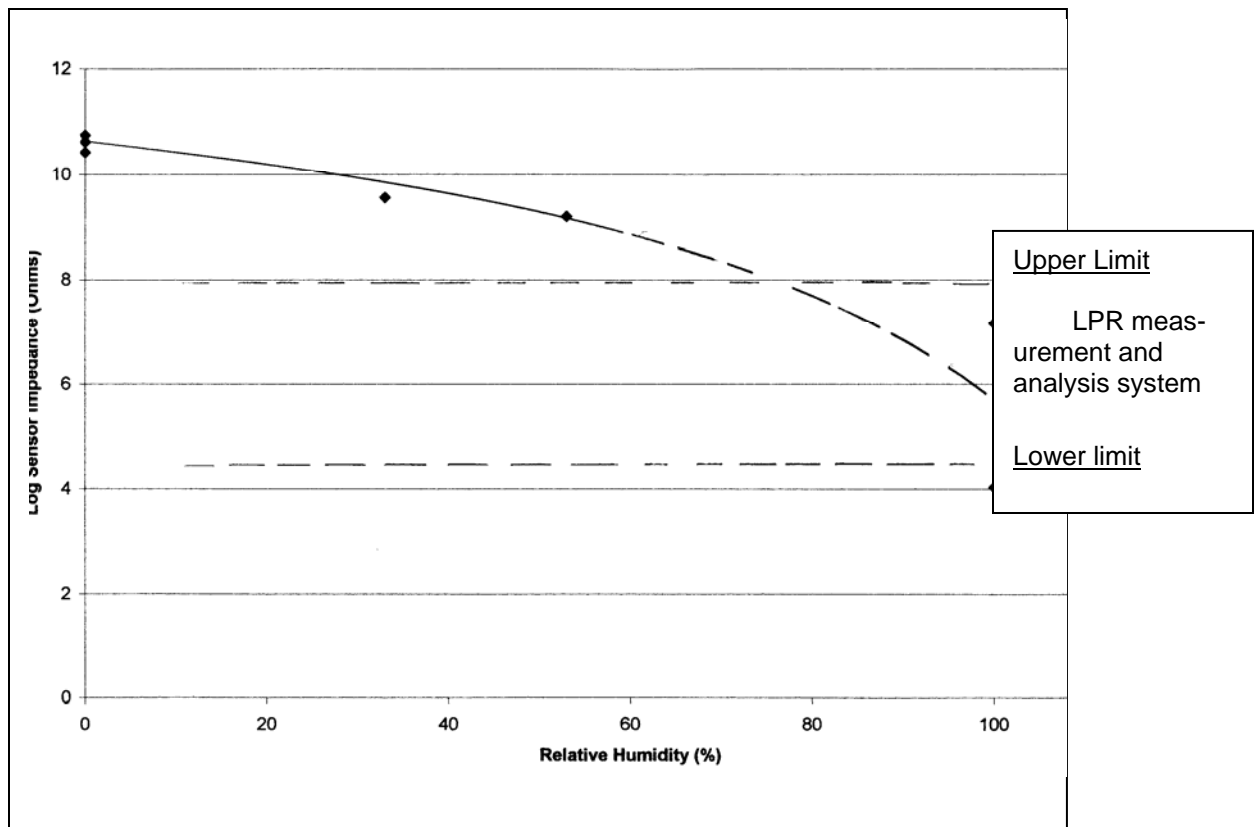
**FIGURE 6 - Log sensor impedance vs. relative humidity.**

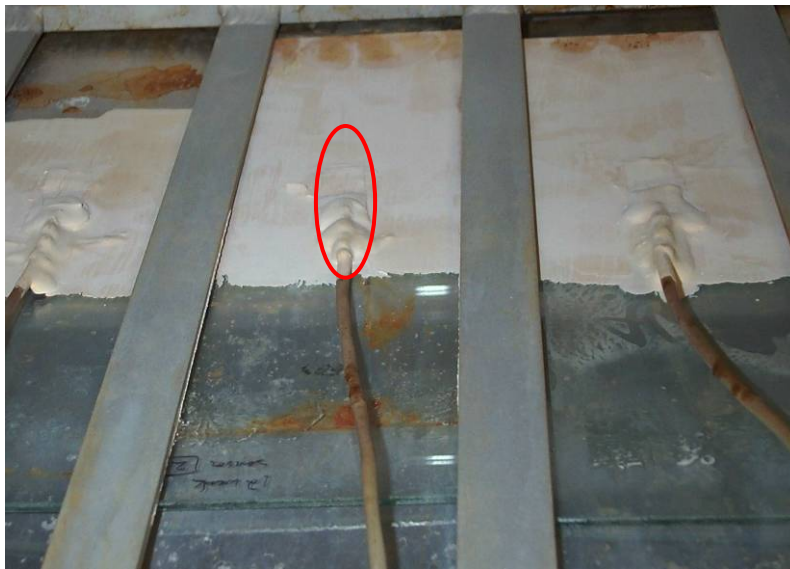
**FIGURE 8 - Test panels consisting of water-borne epoxy coating painted over LPR sensors.**

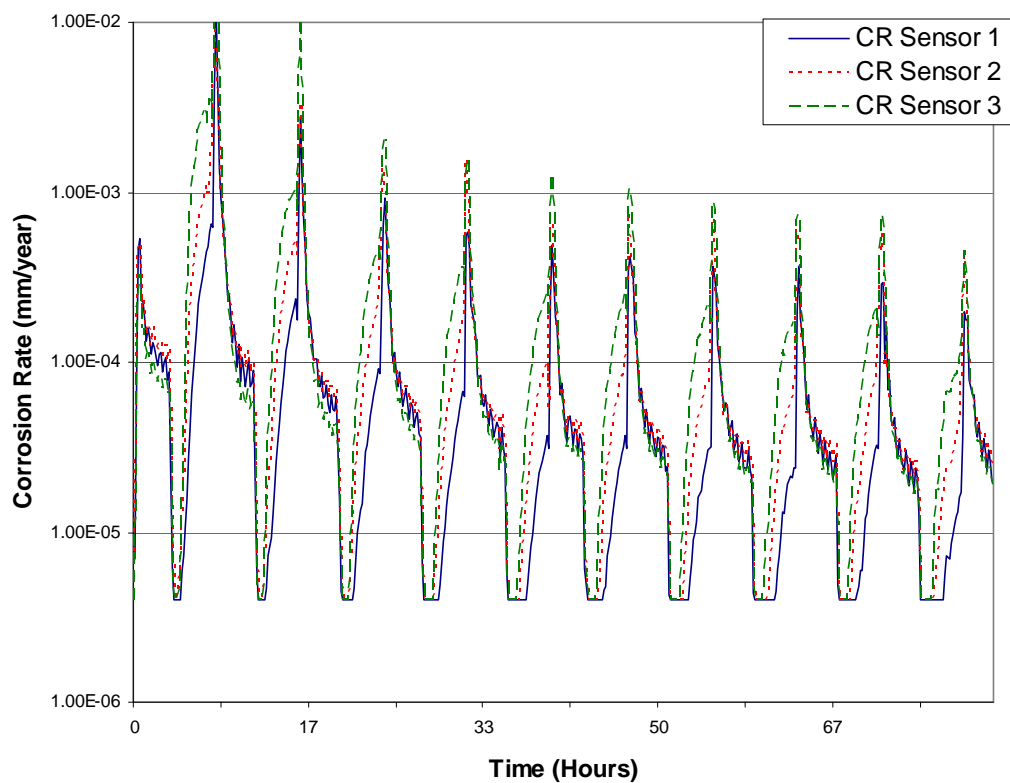
**FIGURE 9a - Corrosion Rate vs. Time for LPR sensor under paint subjected to UV/CON Exposure for 1 Week.**

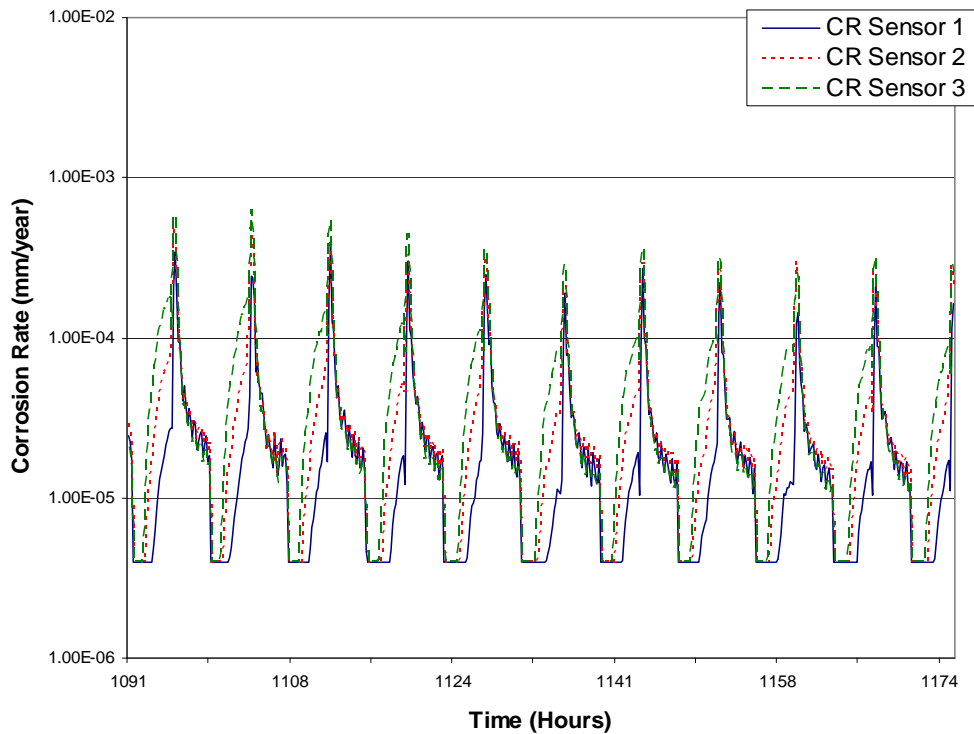
**FIGURE 9b - Corrosion Rate vs. Time for LPR sensor under paint subjected to UV/CON Exposure during Week 6.**

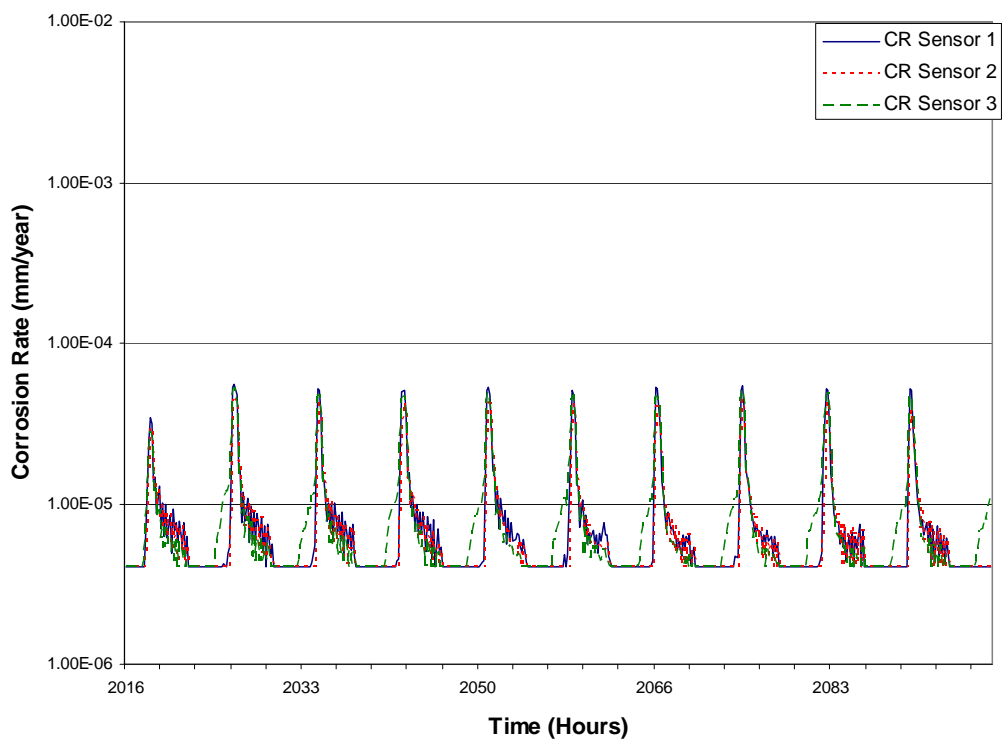
**FIGURE 9c - Corrosion Rate vs. Time for LPR sensor under paint subjected to UV/CON Exposure during Week 12.**

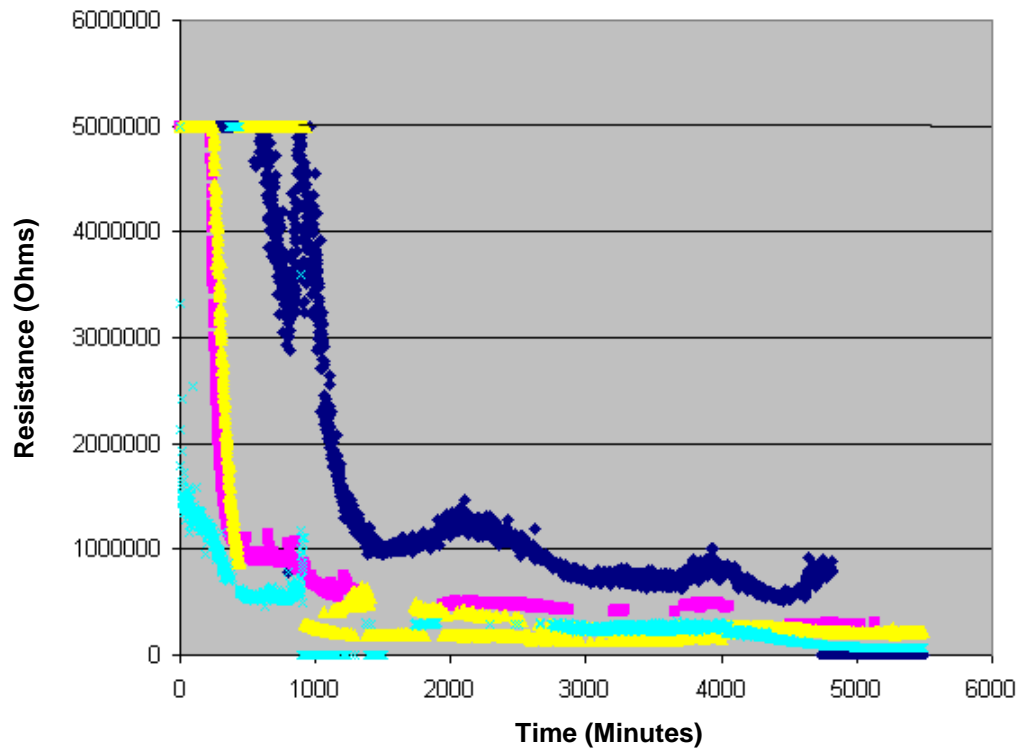
Figure 5. LPR corrosion sensor in tap water humid environment.

This test was primarily done to see if the LPR corrosion sensor would be able to detect corrosion underneath the epoxy paint that was going to be applied on top of the sensors at Torii Station. Therefore, no attempt was made to keep either temperature or humidity at a constant value.

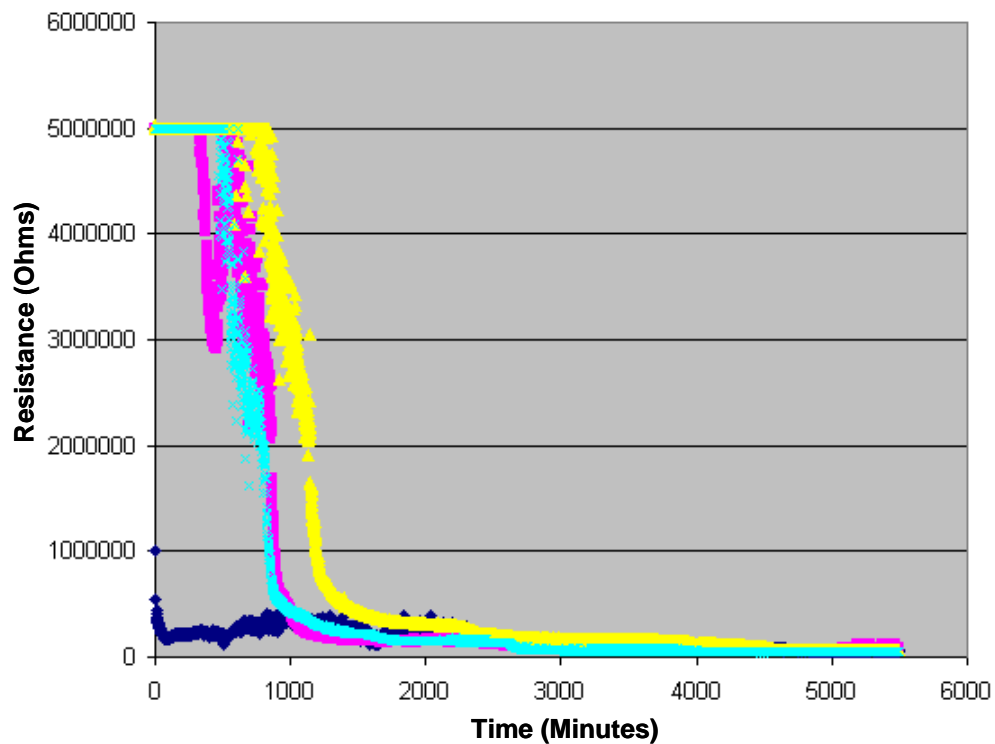
Figure 6. LPR corrosion sensor in salt water humid environment.

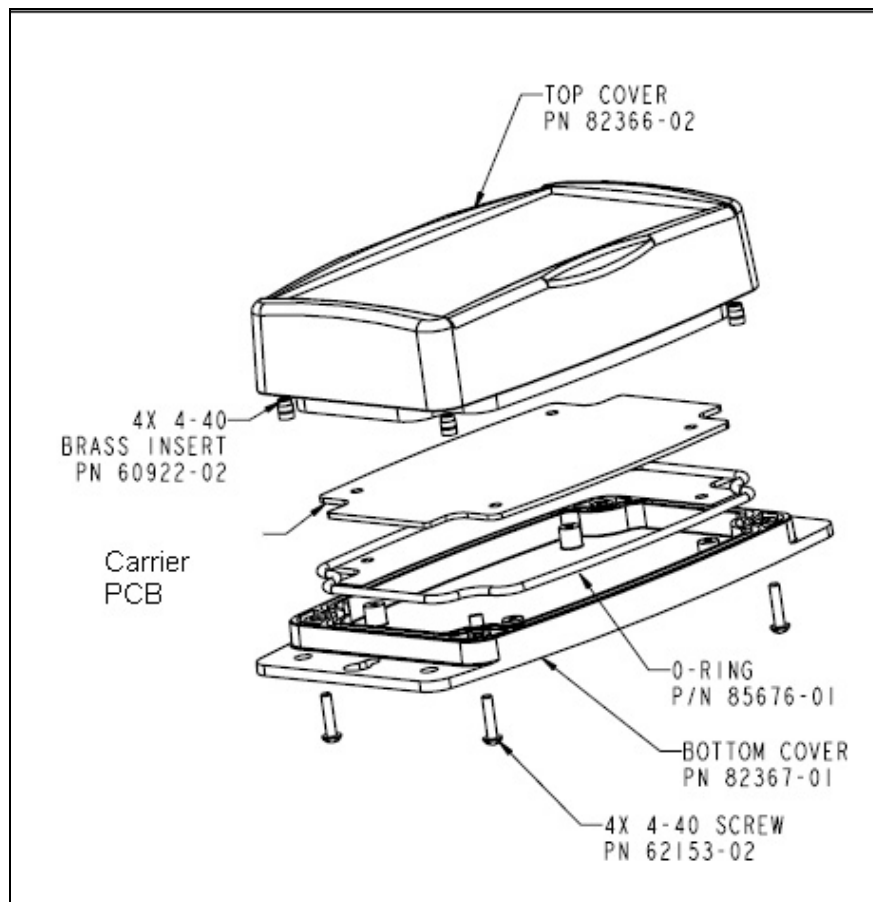
Installation of the electronics for the sensors in this humid environment required special waterproof packaging to make the system more robust and waterproof. In order to meet these requirements, the components used were carefully chosen. The electronics enclosure shown in Figure 1 is a Pactec OD45, which uses a rubber gasket to provide a waterproof seal. The connectors used are Binder 620 series and are shown in Figure 2. They were chosen for both their IP-67 rating (Ingress Protection rating, a measure of water tightness), and their small size allows them to fit in the Pactec enclosure. In order to securely mount the printed circuit board (PCB) without drilling holes in the enclosure (the holes would compromise the water tightness of the enclosure), a carrier PCB was designed. This carrier board had holes that aligned with both the Pactec enclosure and the PCB of the sensor node. The sensor node PCB is attached to the carrier PCB, which in turn is connected to the Pactec enclosure.

Figure 1. Waterproof Pactec OD 45 LPR System Electronics Node Enclosure

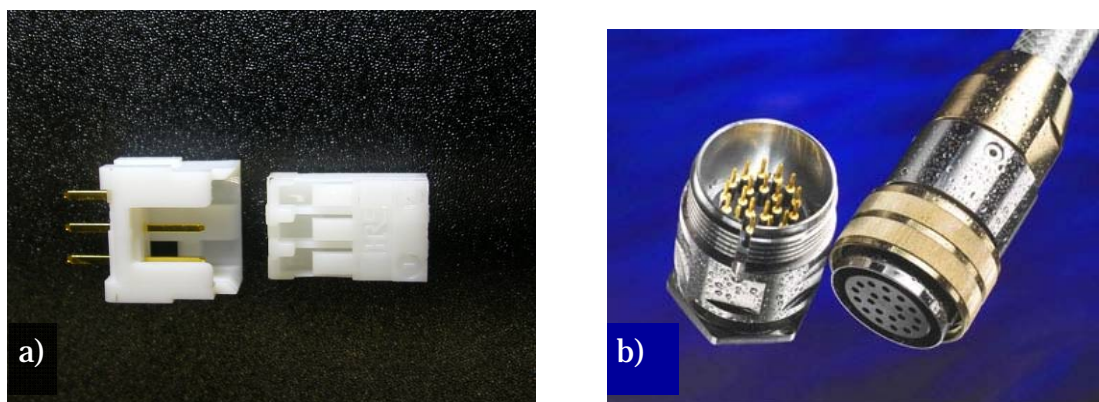
Figure 5. a) Current connector and b) Connector for this project.

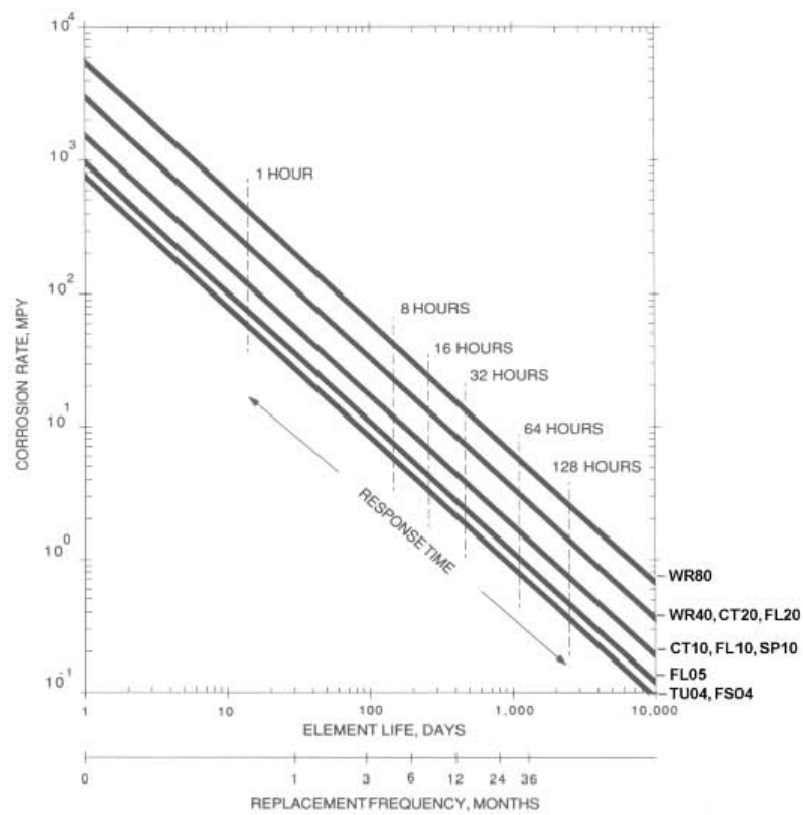
Since probe life and response time are directly proportional, element selection is a compromise between data frequency and probe replacement frequency. The graphical relationship between corrosion rate, probe life, and response time for all elements normally available from Metal Samples Corrosion Monitoring Systems is shown in Figure 4.

Figure 4. Element Selection Guide

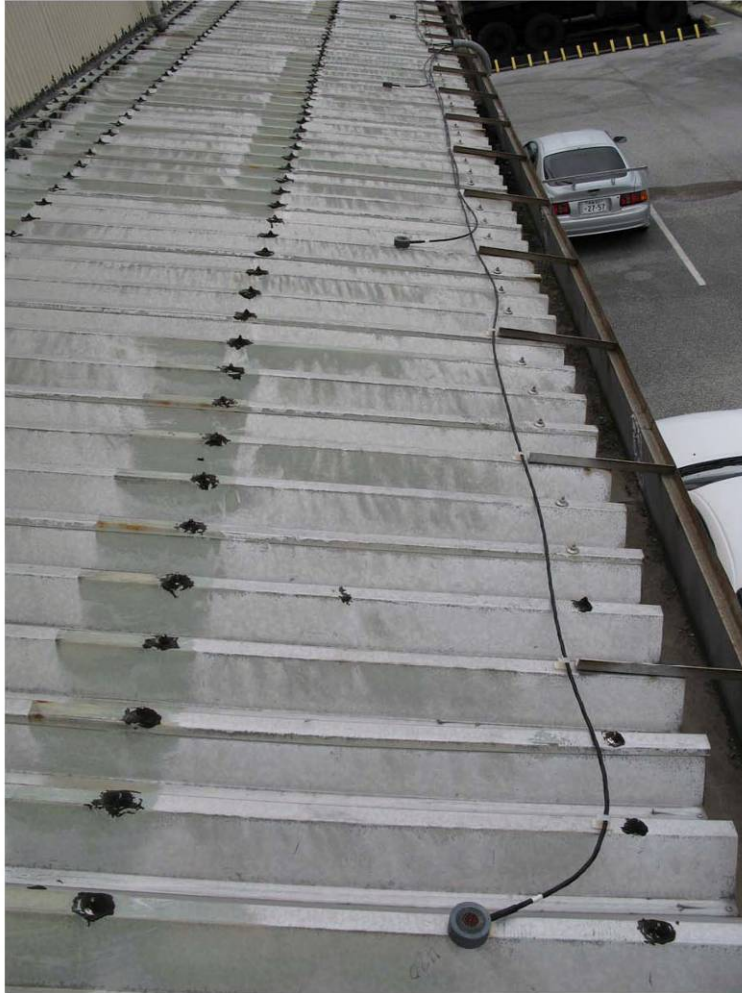
01. View of corrosion probes on roof.

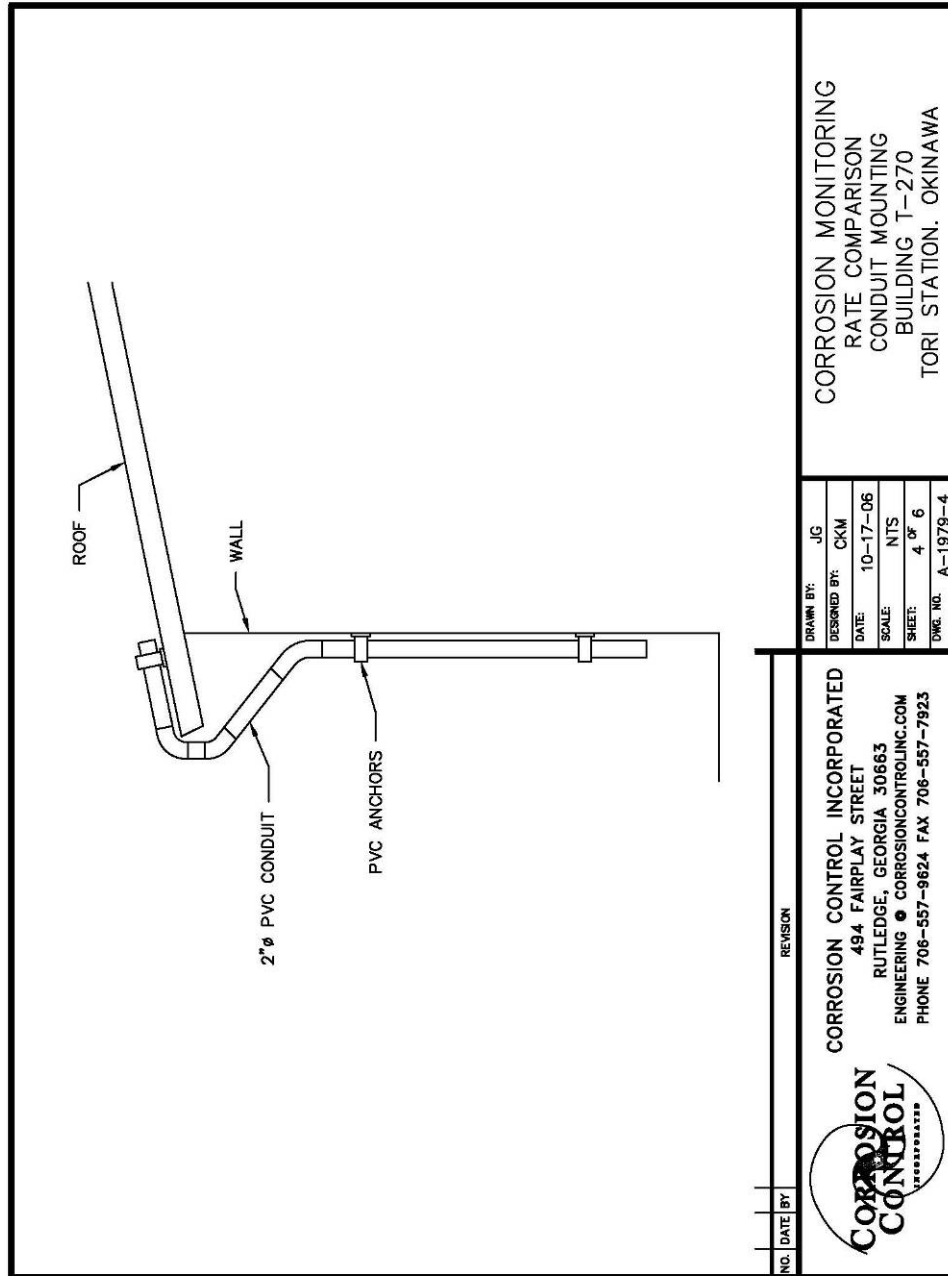
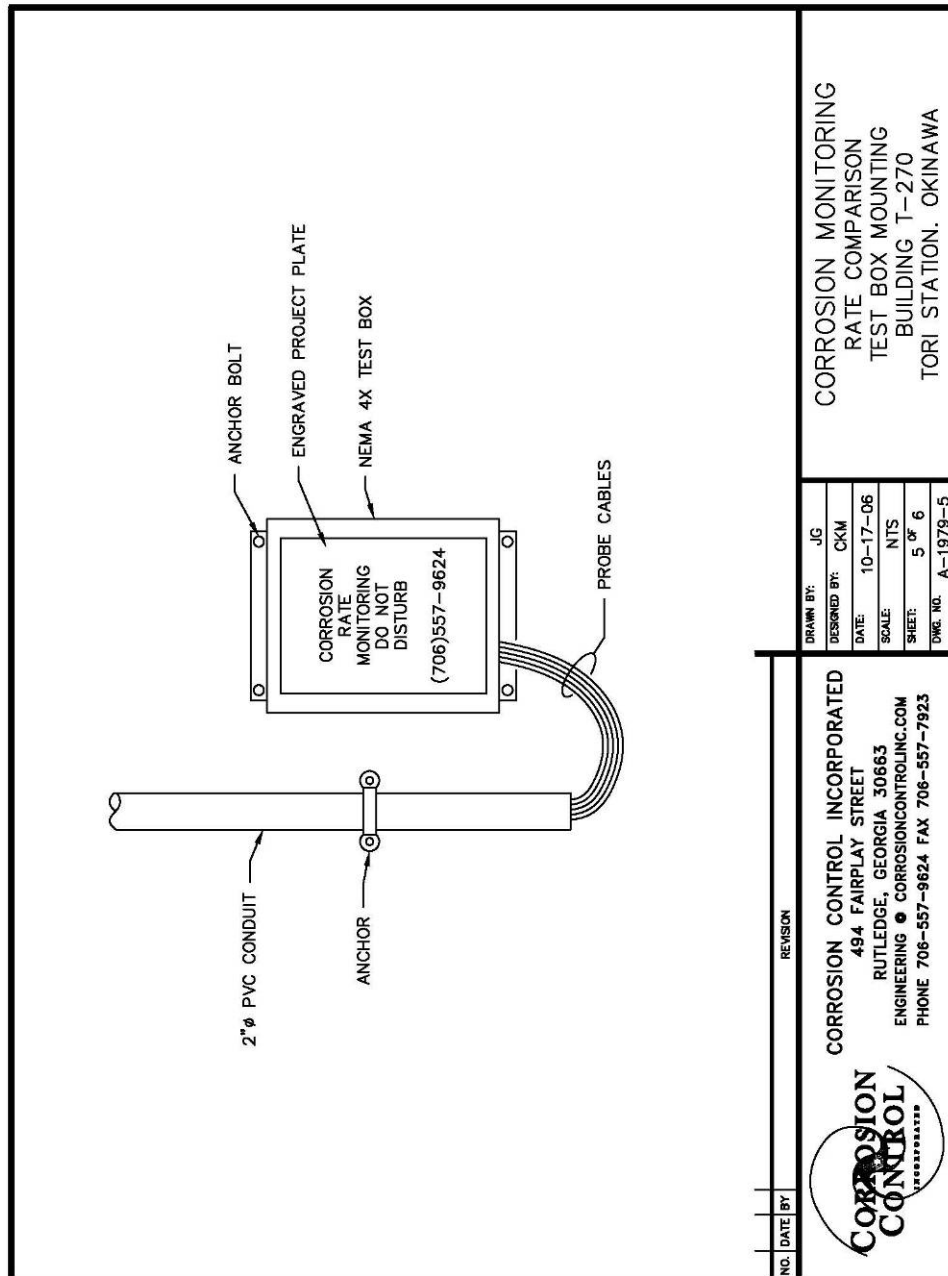
CORROSION MONITORING  
RATE COMPARISON  
CABLE ANCHOR  
BUILDING T-270  
TORI STATION, OKINAWA

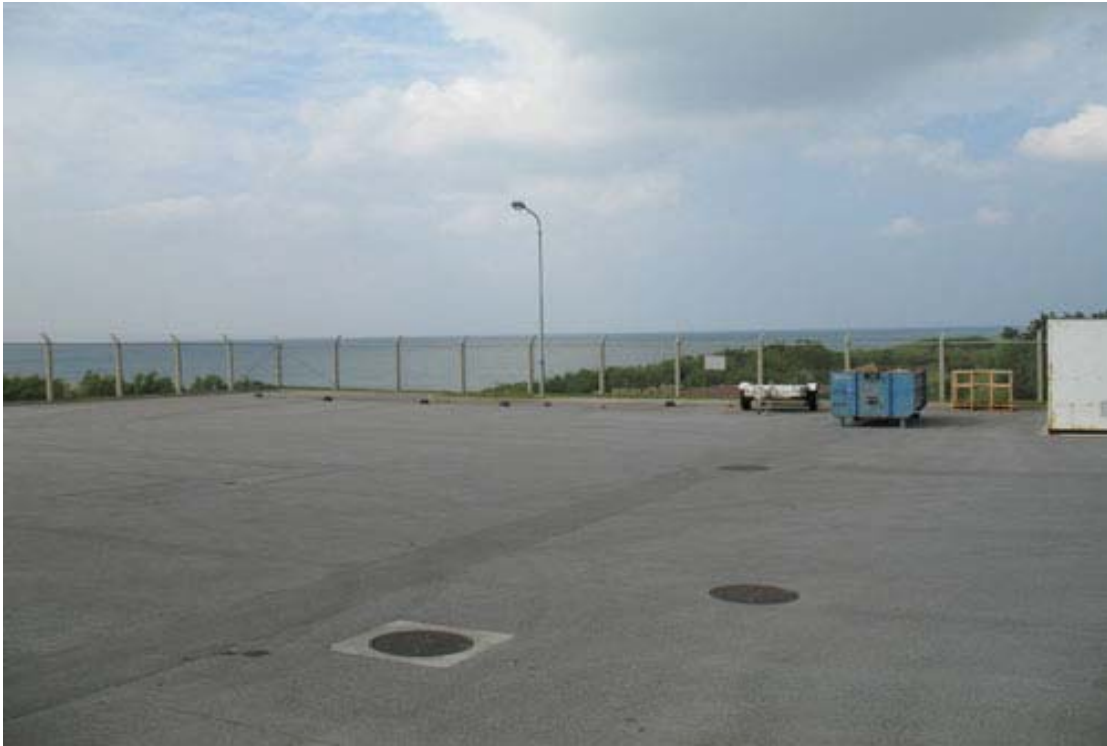
Figure 1a – View of location behind building No. 300 where one set of test racks was exposed ~500-ft from the ocean

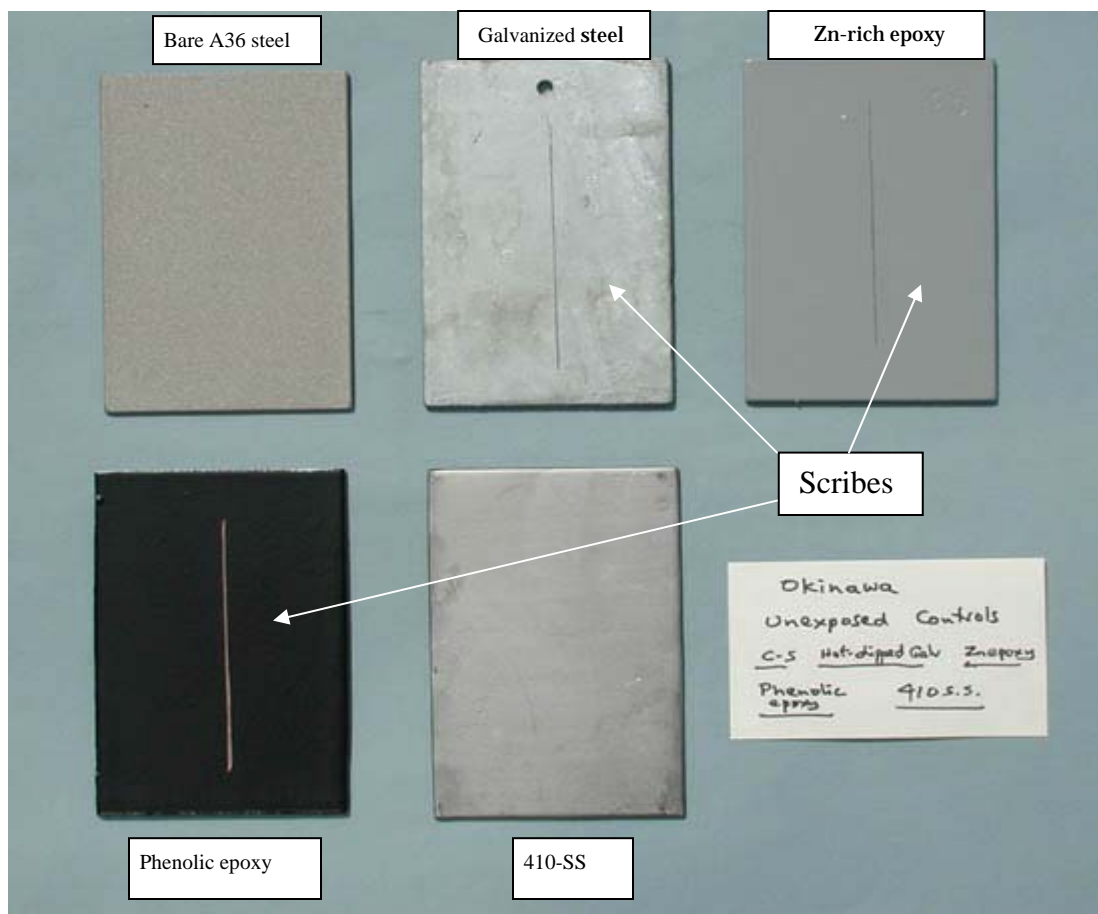
Figure 3 – Unexposed controls

- Top Row: Left – grit-blasted bare carbon steel, Center – hot-dip galvanized steel, Right – Zn-rich primer with epoxy topcoat.
- Bottom row: Left – phenolic epoxy, Right – Type 410 stainless steel.

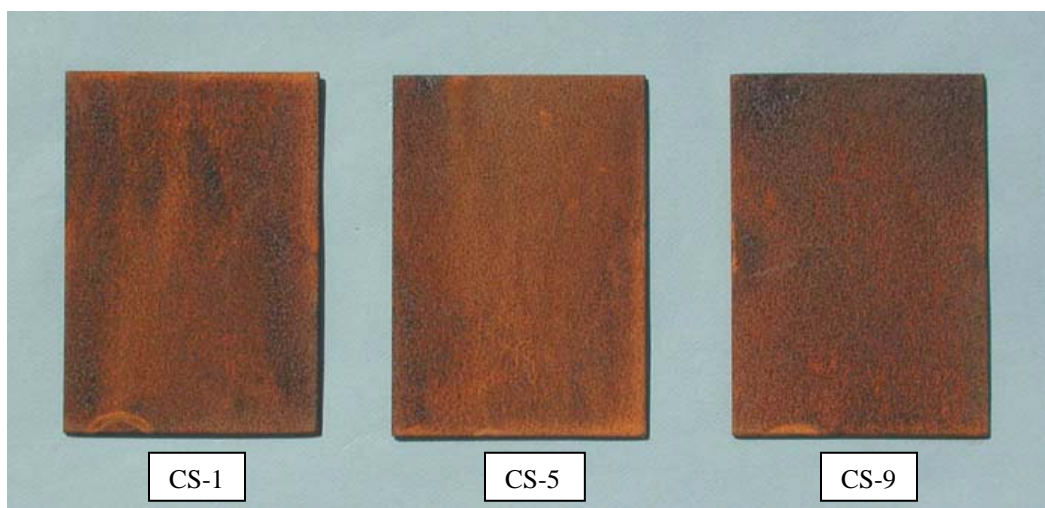
Figure 4a – Carbon steel: 1st removal (79 days); ~500-ft, front face

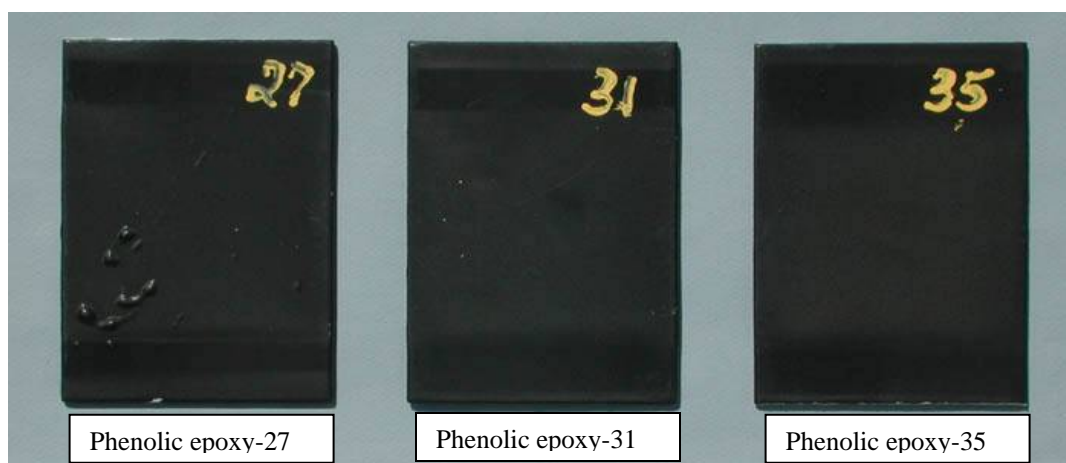
Figure 7b – Phenolic-epoxy coated steel, 1st removal (79 days); 500-ft, backside; the “bubbles” in the coating on panel #27 are drips from the original application and blisters due to coating deterioration

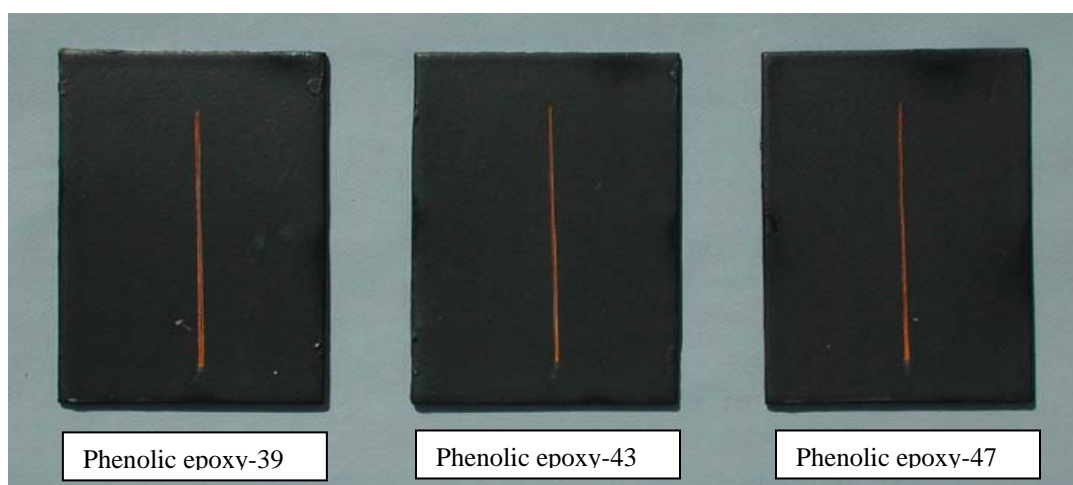
Figure 7c – Phenolic epoxy coated steel, 1st removal (78 days); 2000-ft, front face

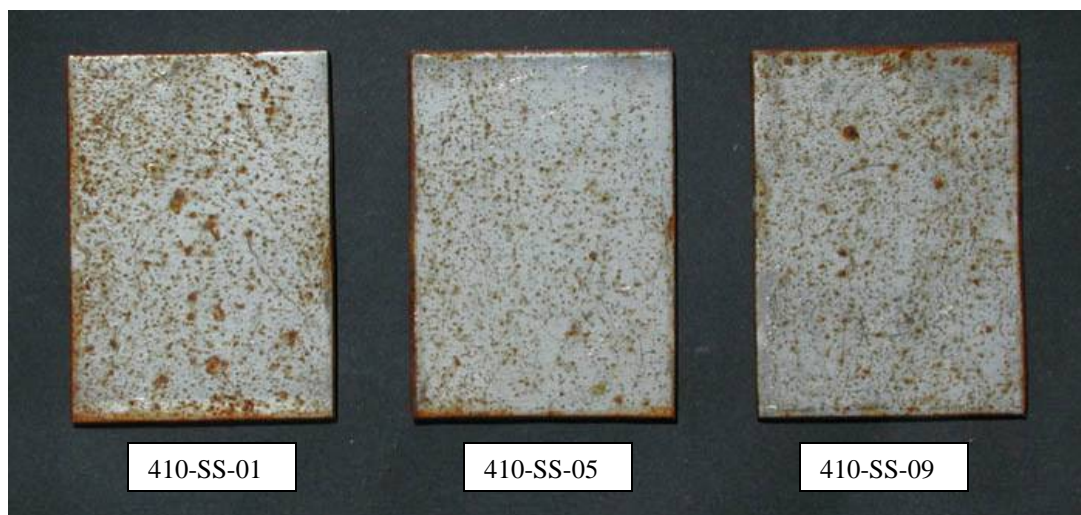
Figure 8a – Type 410 Stainless steel, 1<sup>st</sup> removal (79 days); 500-ft, front face

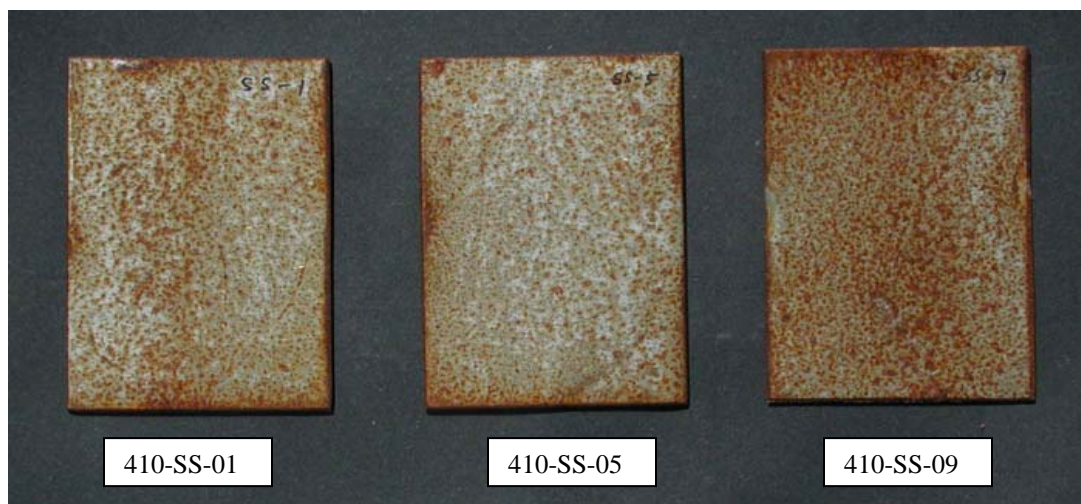
Figure 8b – Type 410 Stainless steel, 1<sup>st</sup> removal (79 days); 500-ft, backside

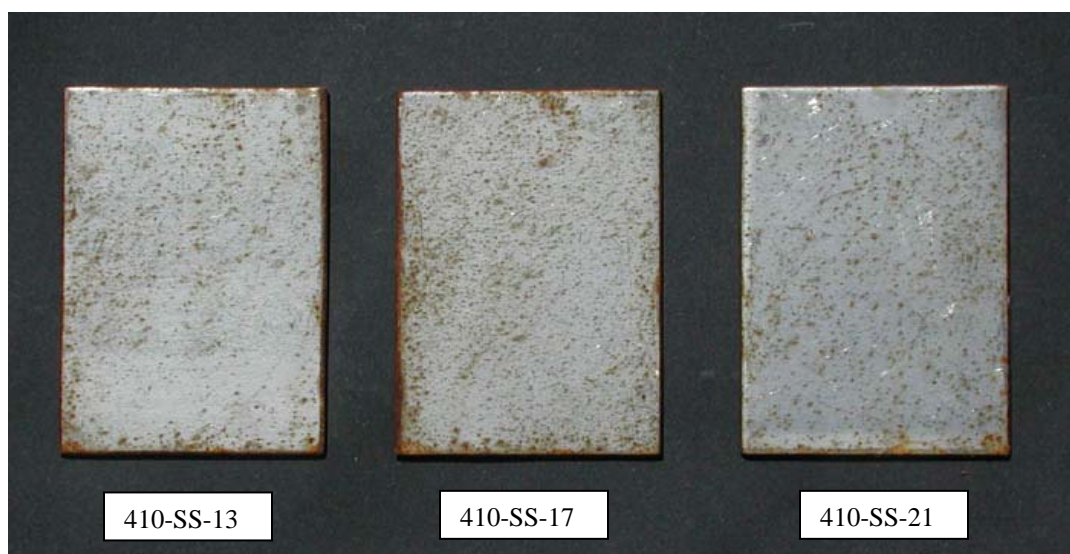
Figure 8c – Type 410 Stainless steel, 1<sup>st</sup> removal (78 days); 2000-ft, front face

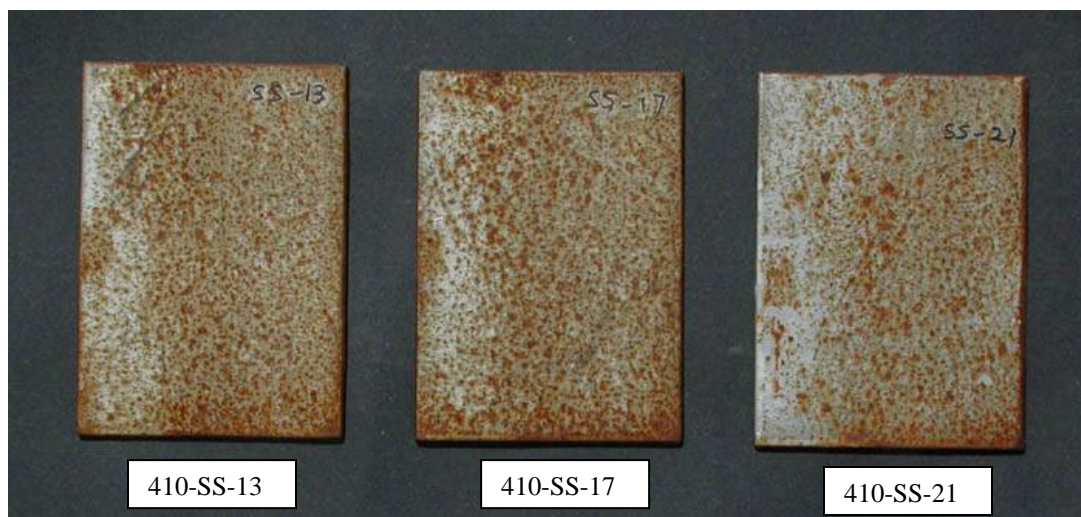
Figure 8d – Type 410 Stainless steel, 1<sup>st</sup> removal (78 days); 2000-ft, backside
